INVESTIGATION OF TANTALUM WET SLUG CAPACITOR FAILURES IN THE APOLLO TELESCOPE MOUNT CHARGER BATTERY REGULATOR MODULES

INTERNATIONAL BUSINESS MACHINES CORP.,
HUNTSVILLE, ALA. ELECTRONICS SYSTEMS
CENTER

31 JAN 1973

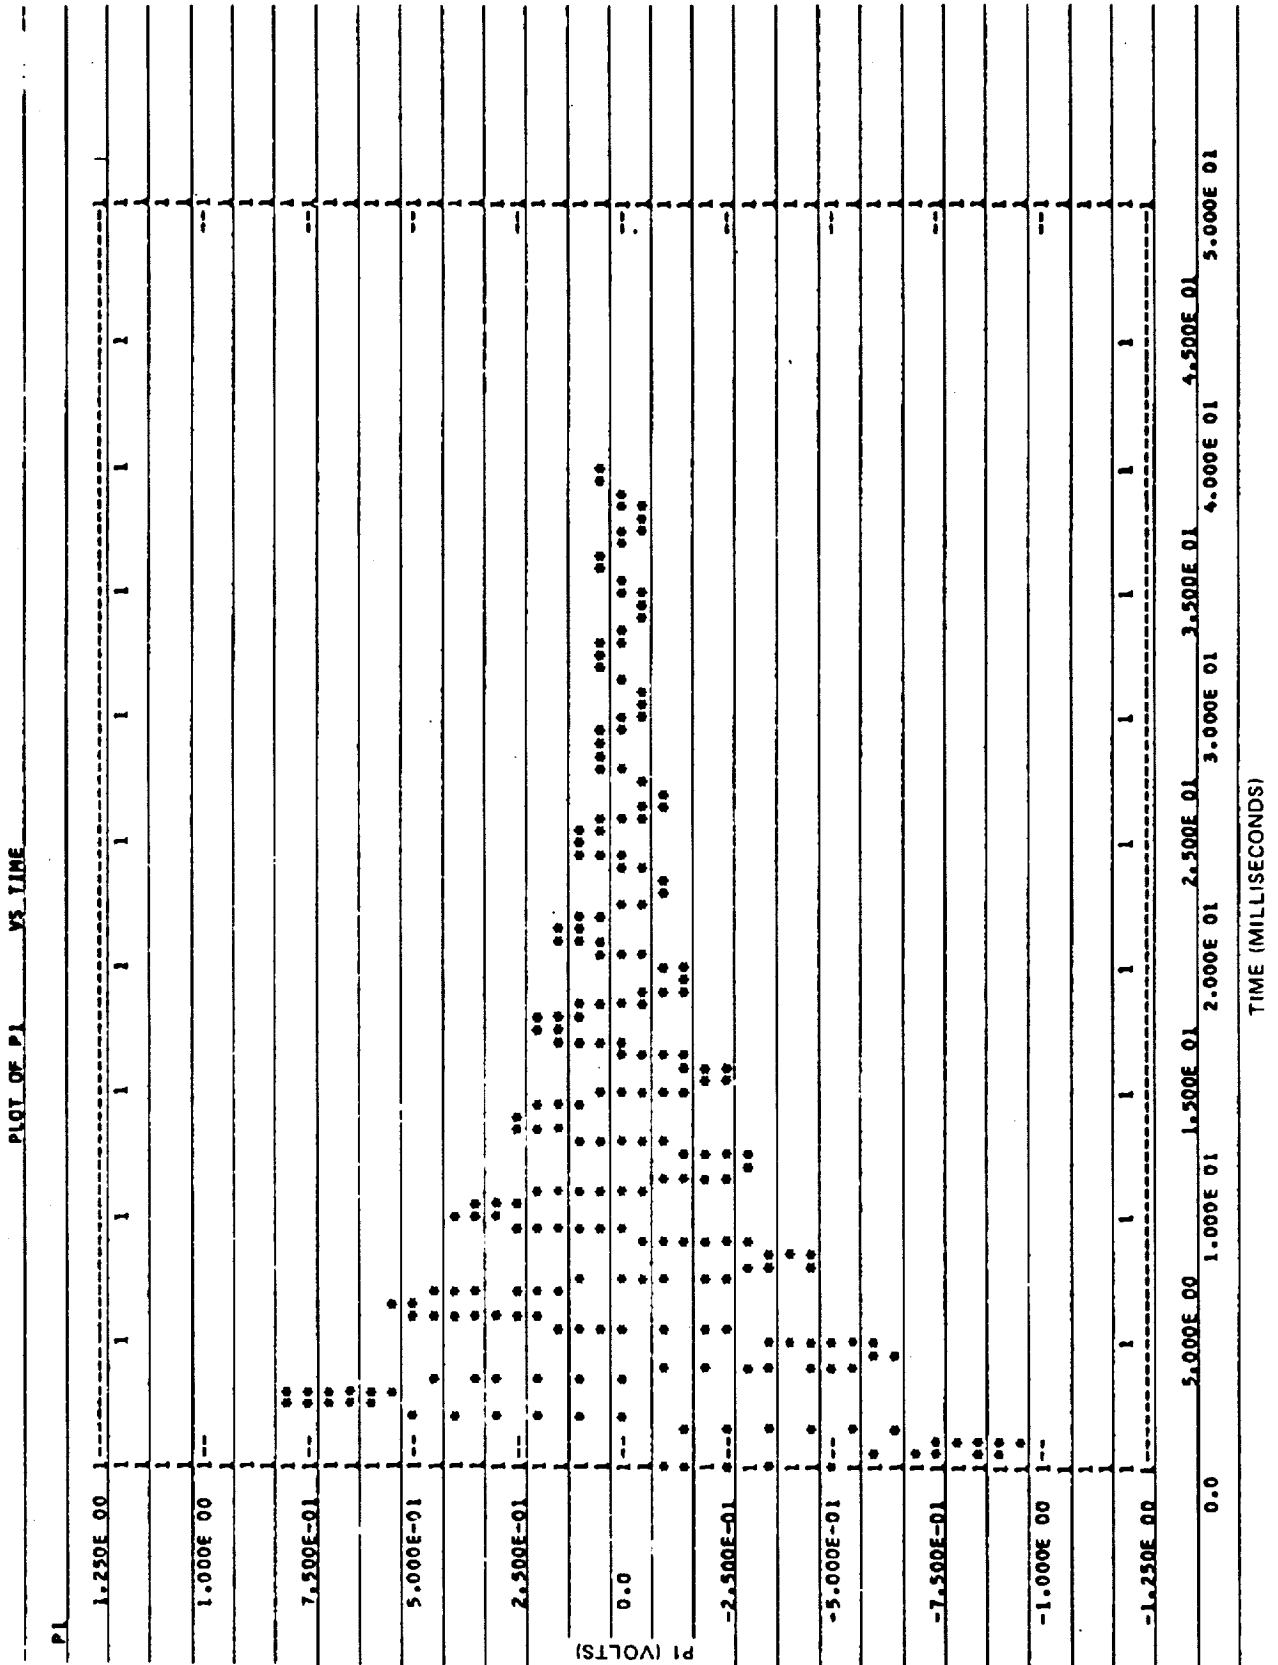
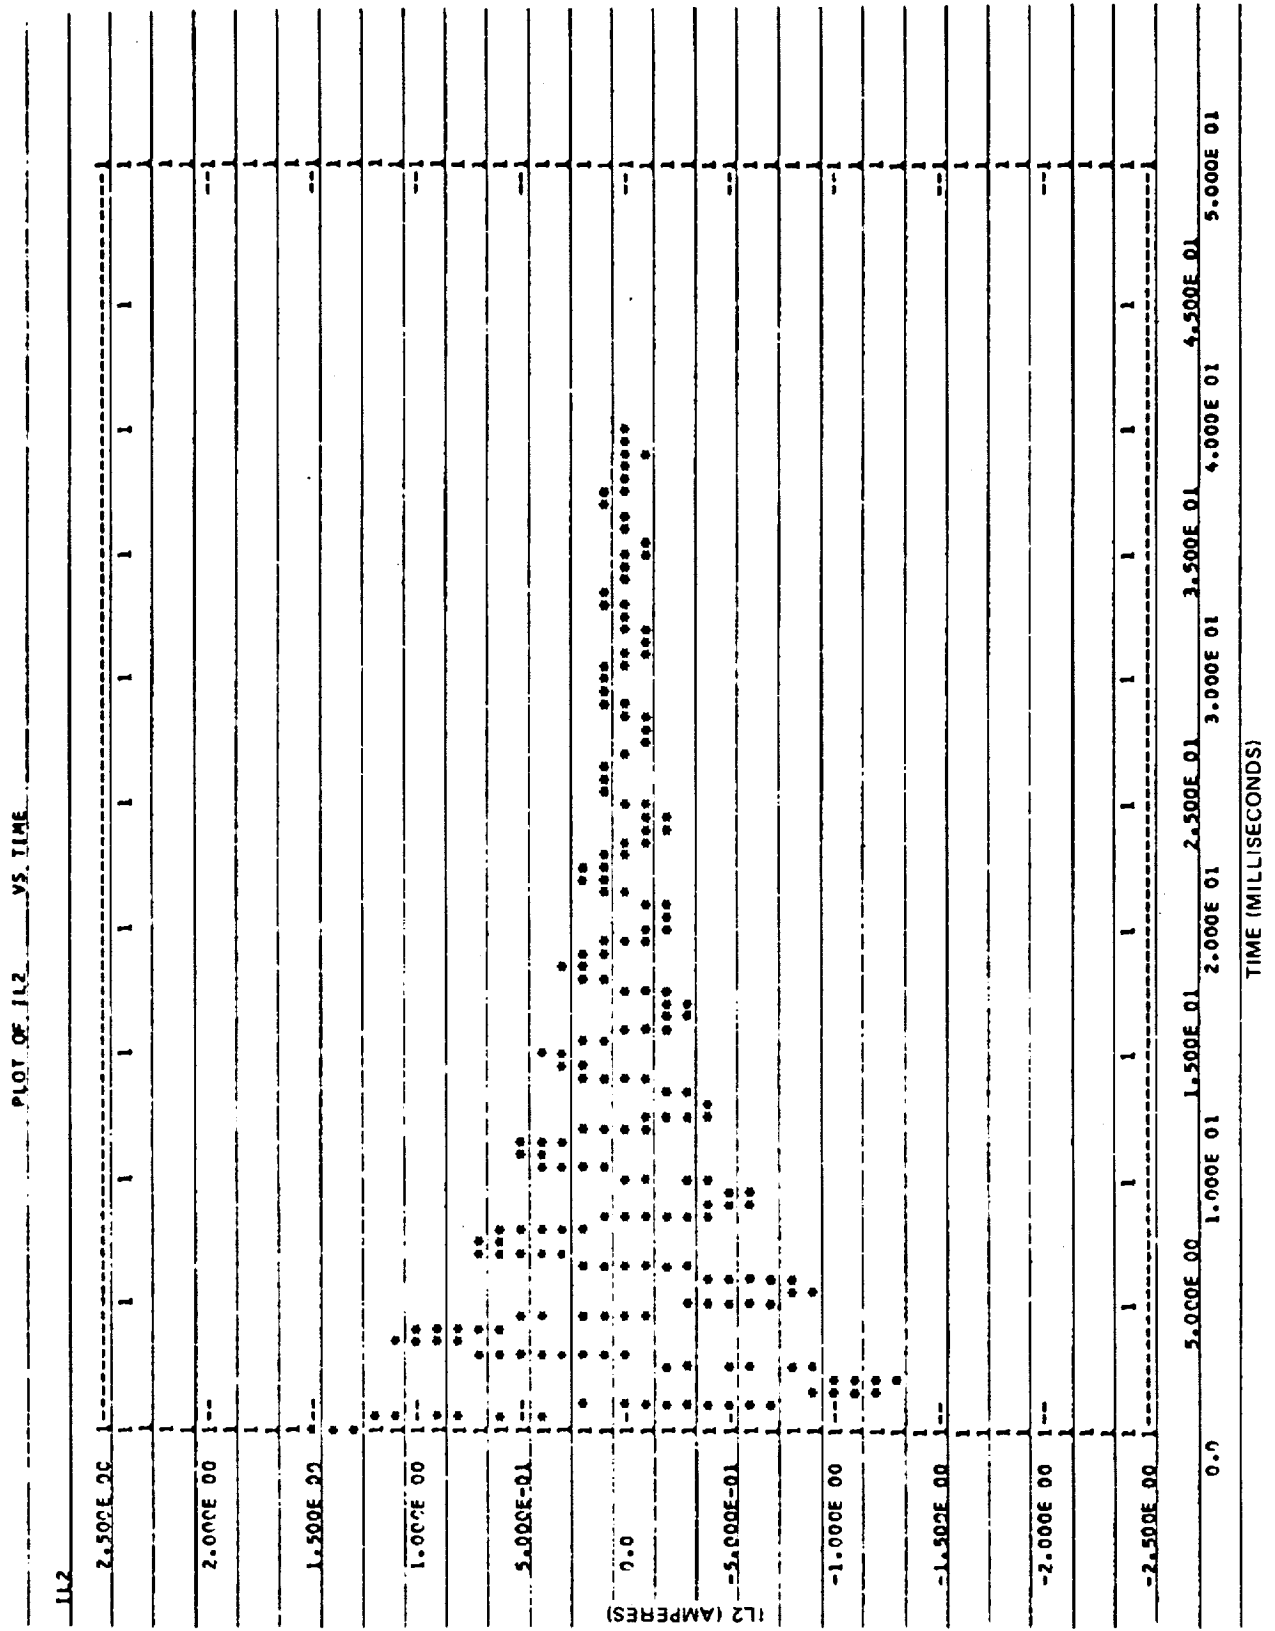
Figure 6.4-13. Plot of Input Capacitor Voltage vs Time.

Figure 6.4-14. Plot of Output Capacitor Voltage vs Time.

Figure 6.4-15. Plot of L2 Current vs Time.

The equivalent circuit for the electrical conditions during battery trickle charger turn-off is shown in Figure 6.4-12. An initial condition of 1.5 amperes was assumed through inductor L2. Again reverse bias conditions were predicted across both the input and output capacitors in the input filter during the transient. The input capacitors saw a maximum of 0.93 volts reverse bias, and the output capacitors experienced a 0.19 volt reverse bias. The transient waveforms are shown in Figures 6.4-13 through 6.4-15.

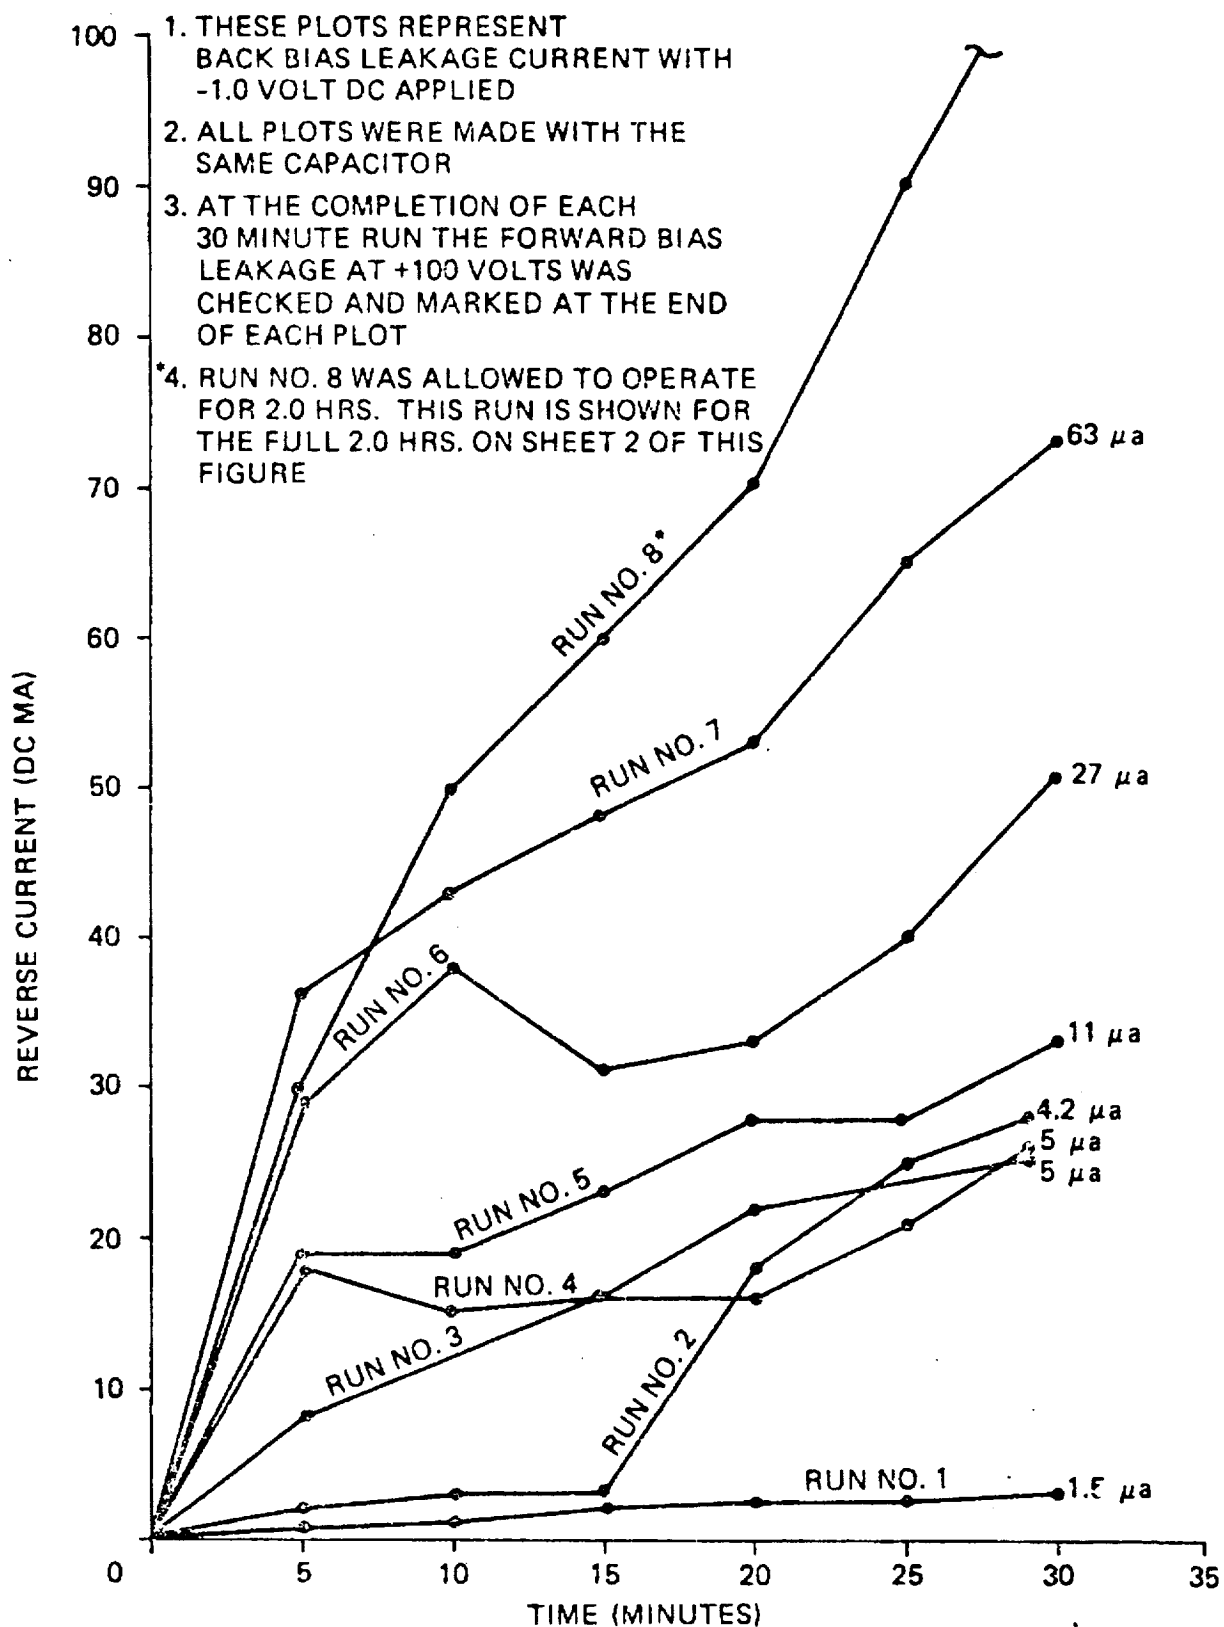
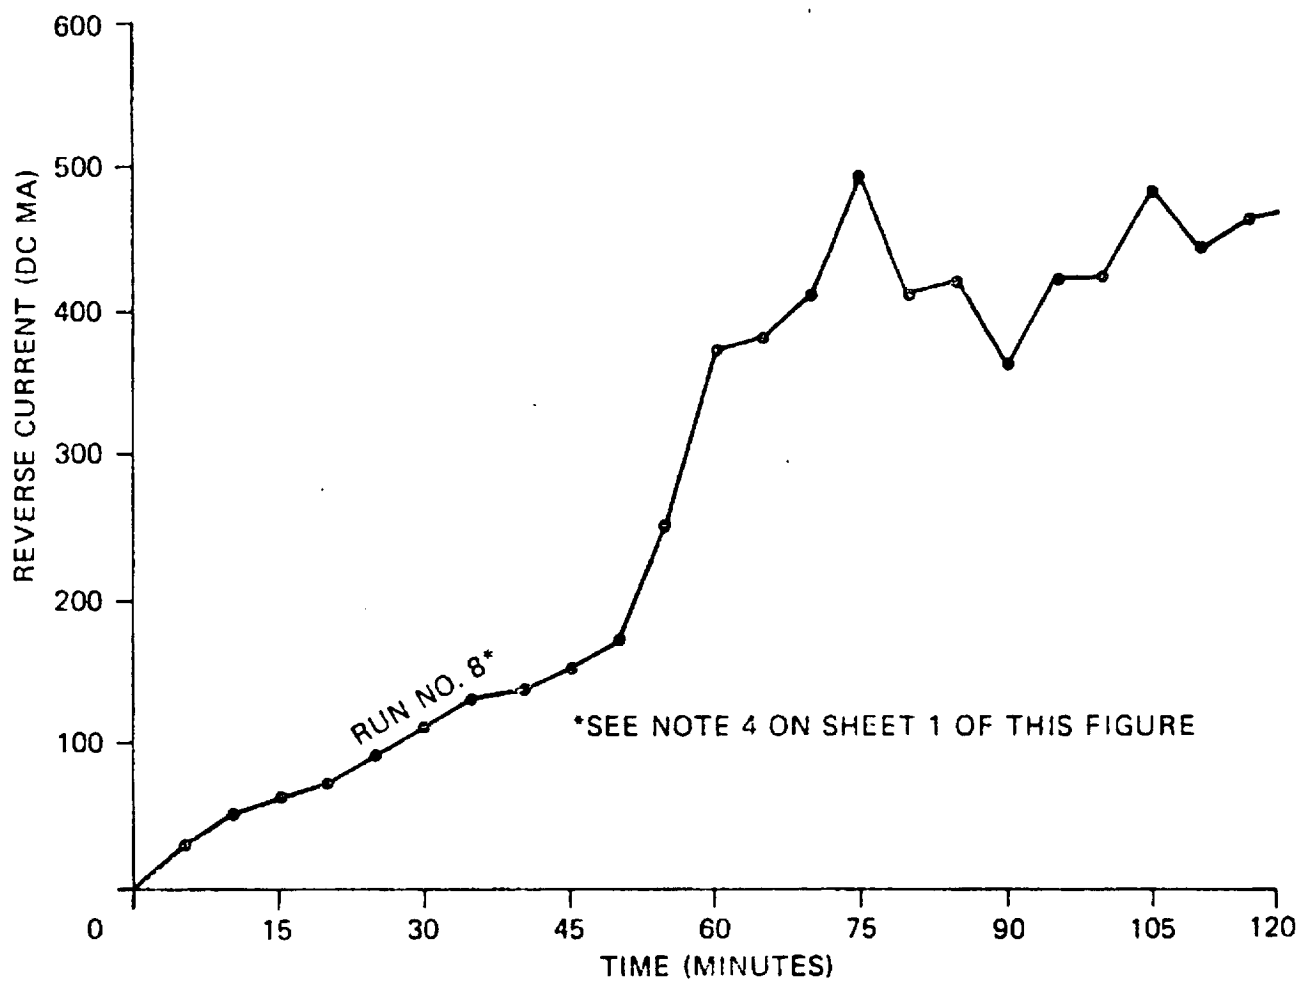
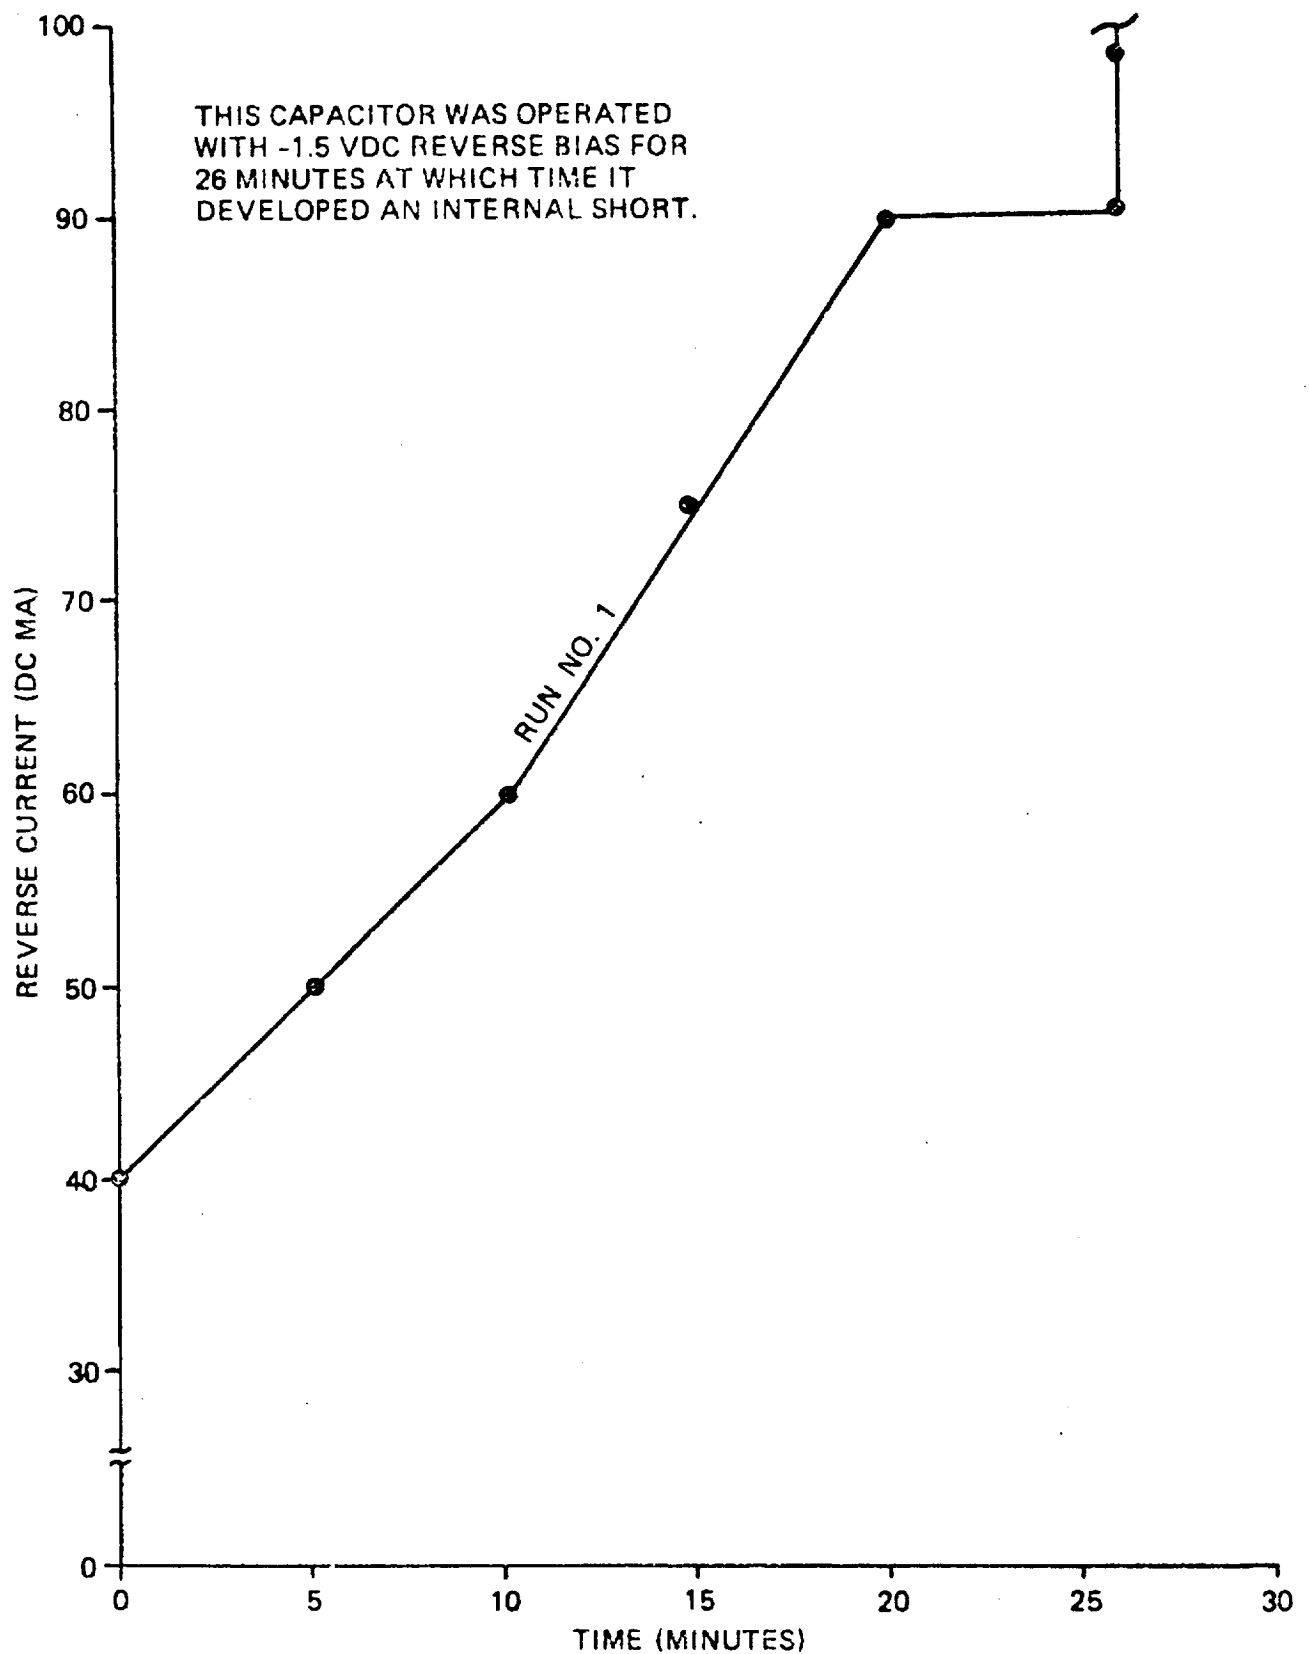
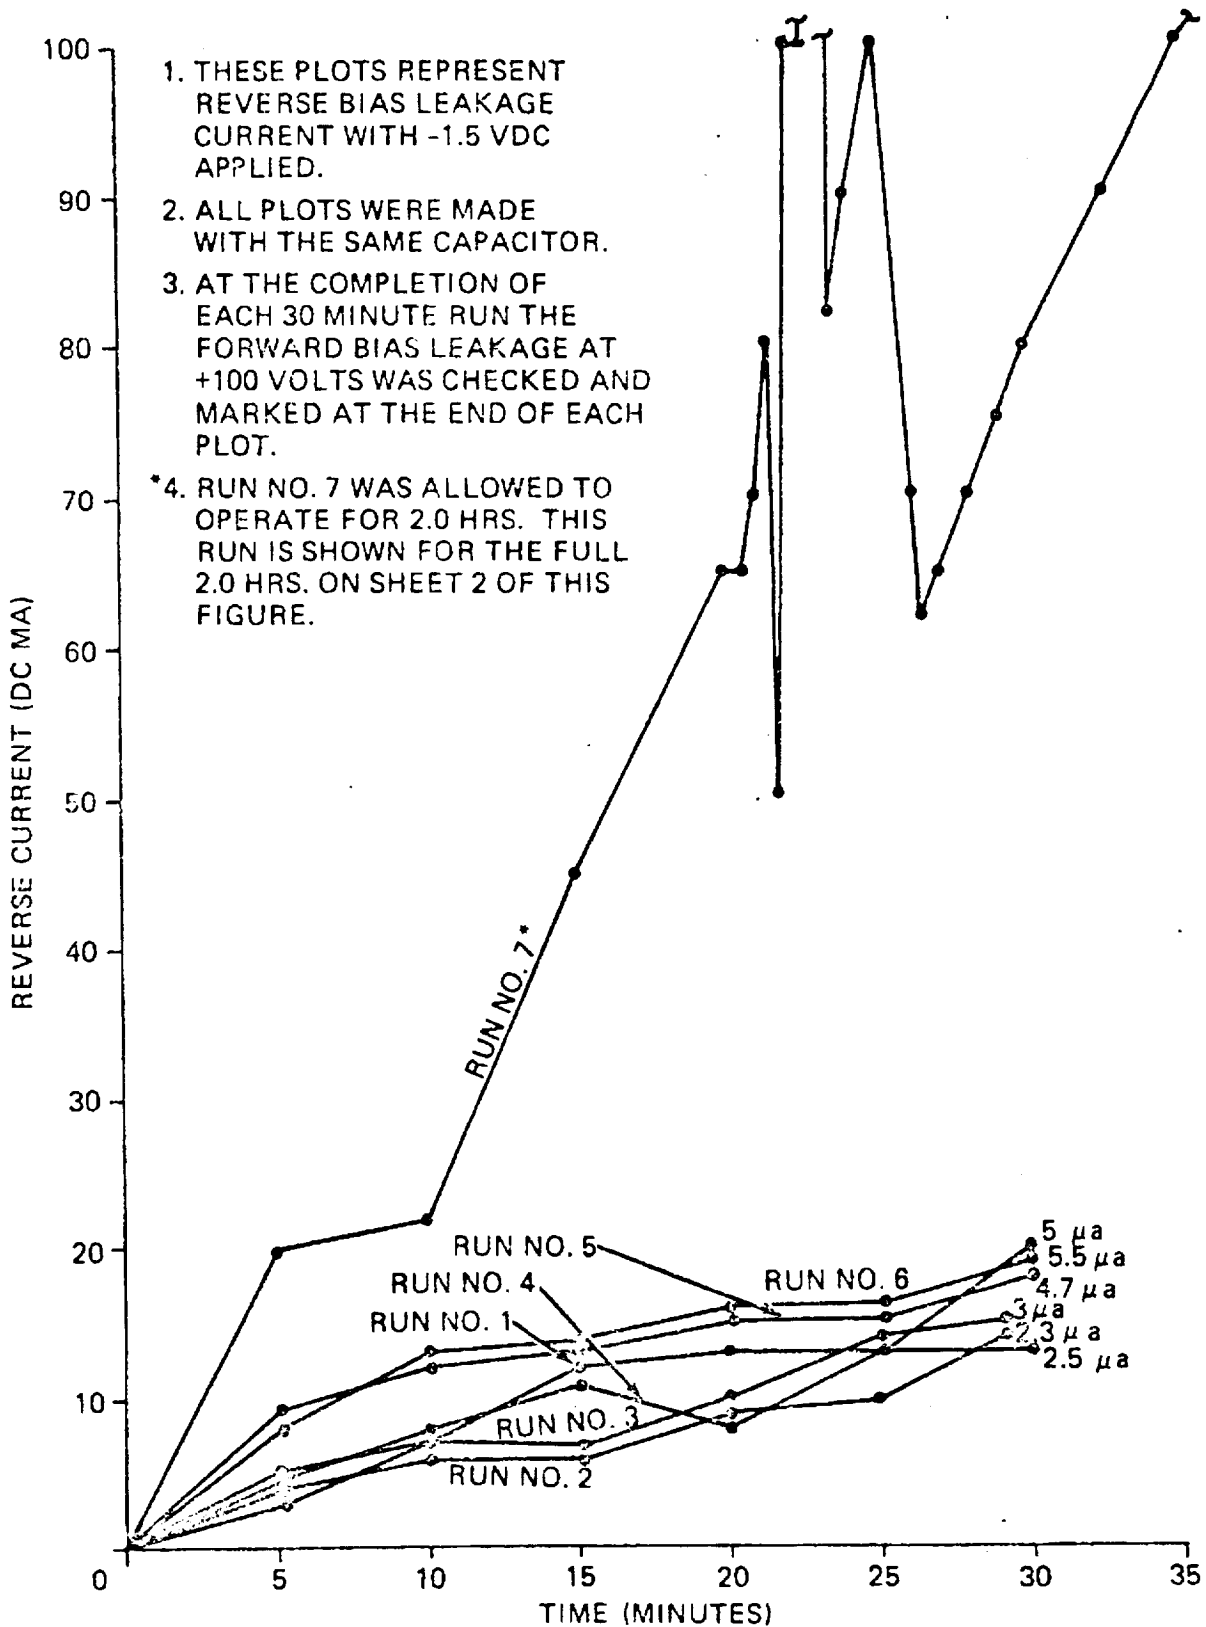
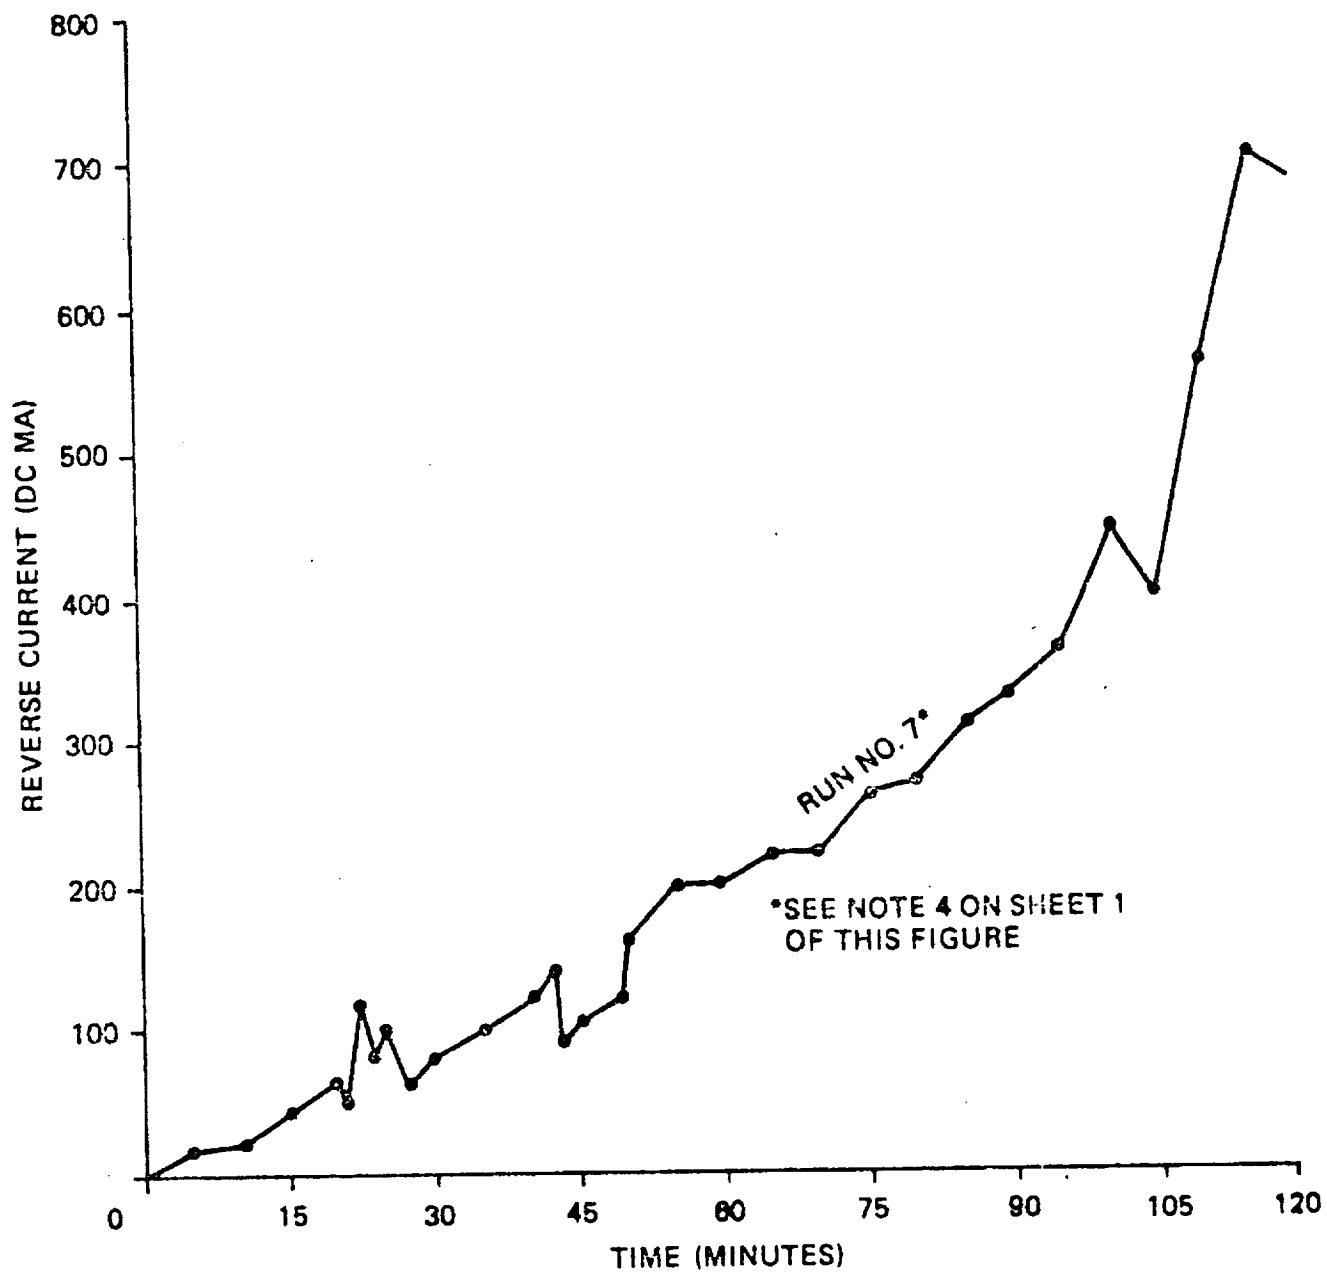
Figure 6.6.3.3.2-1. Sample No. 1 Data for Duty Cycle Test No. 2. (1 of 2)

Figure 6.6.3.3.2-1. Sample No. 1 Data for Duty Cycle Test No. 2. (2 of 2)

Figure 6.6.3.3.2-2. Sample No. 2 Data for Duty Cycle Test No. 2.

Figure 6.6.3.3.2-3. Sample No. 3 Data for Duty Cycle Test No. 2. (1 of 2)

Figure 6.6.3.3.2-3. Sample No. 3 Data for Duty Cycle Test No. 2. (2 of 2)

third samples were evaluated in the same manner except the reverse bias was increased to 1.5 volts. The results of this evaluation are shown in Figures 6.6.3.3.2-1 thru 6.6.3.3.2-3.

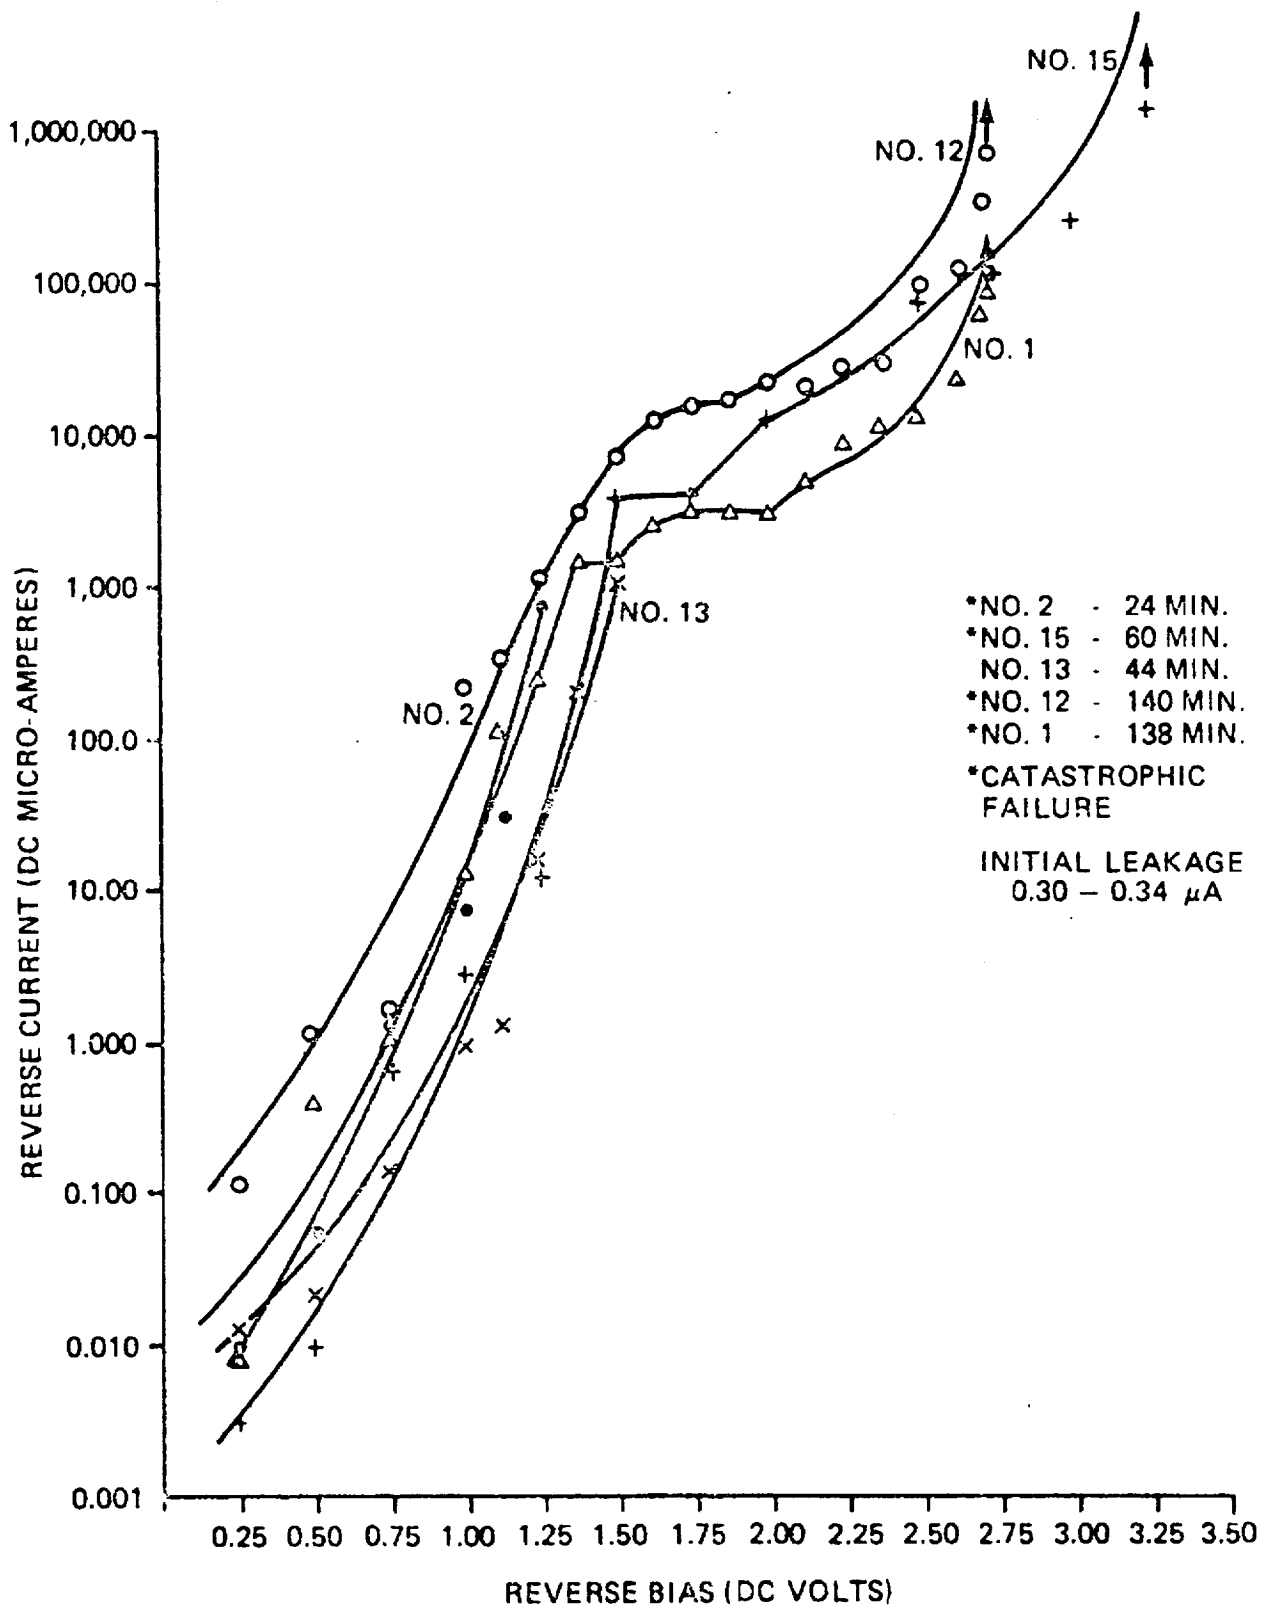
Figure 6.6.3.4-1. Reverse Bias Diode Effect

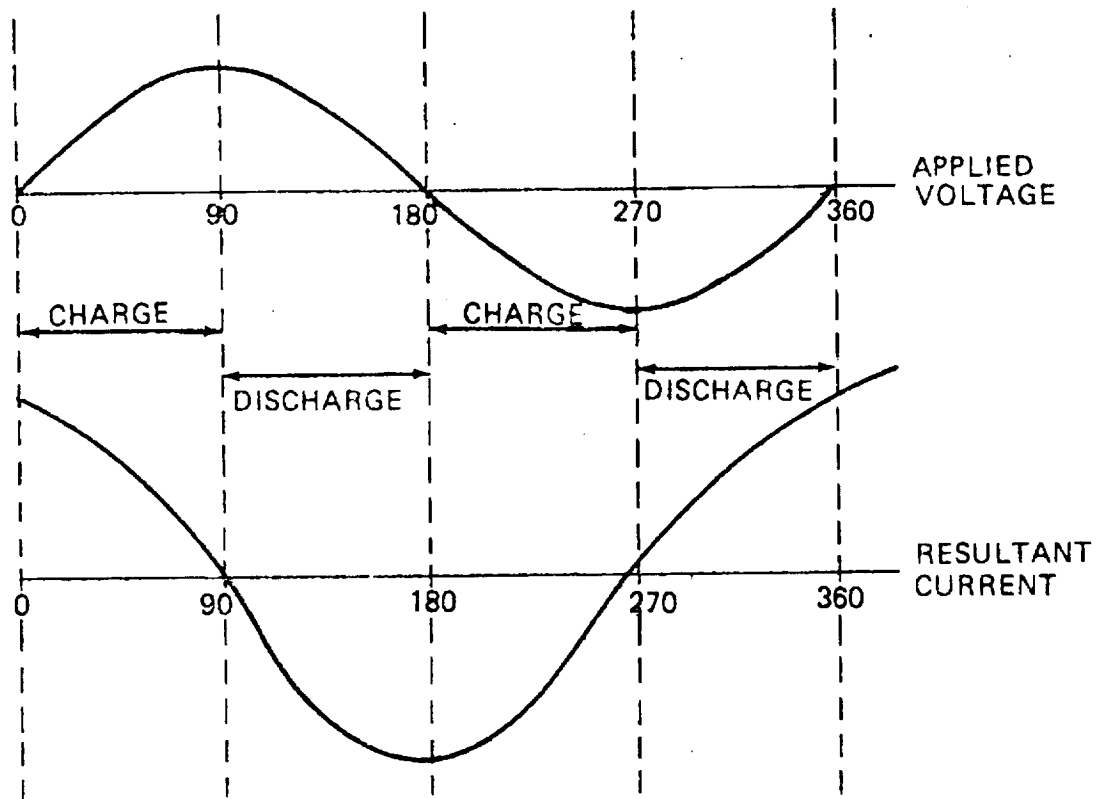
Figure 6.6.3.5-1. Normal Capacitor AC Waveforms.

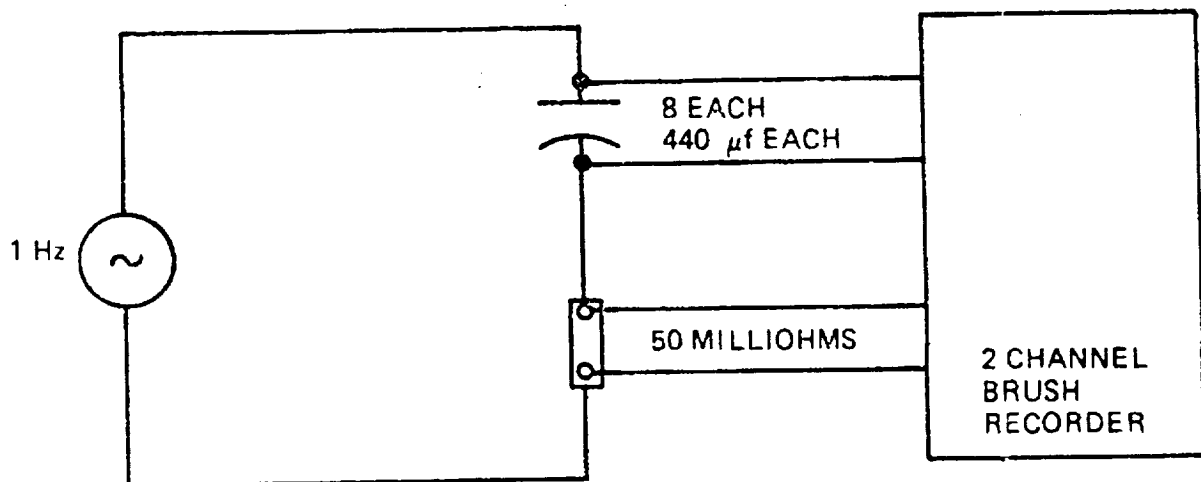
Figure 6.6.3.5-2. Test Schematic for AC Test on Capacitors.

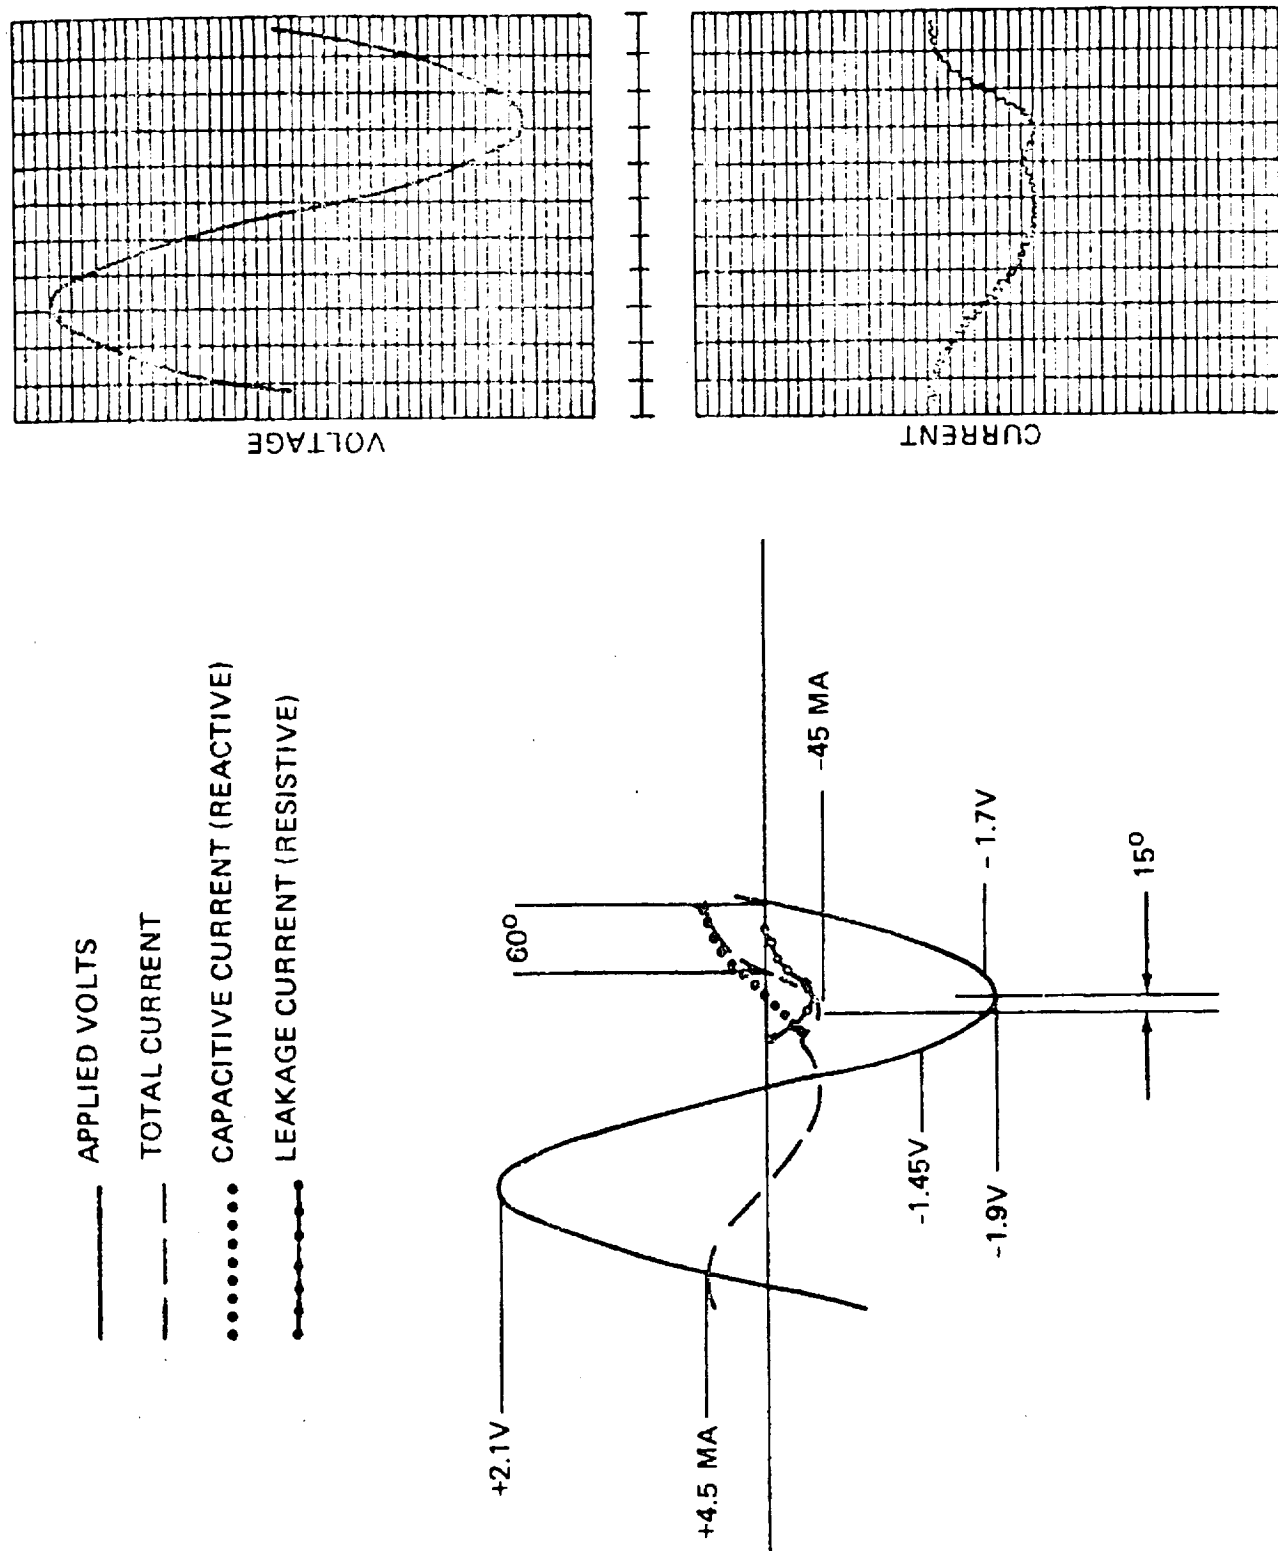
Figure 6.6.3.5-3. AC Voltage and Current Waveforms Showing Reverse Leakage Current.

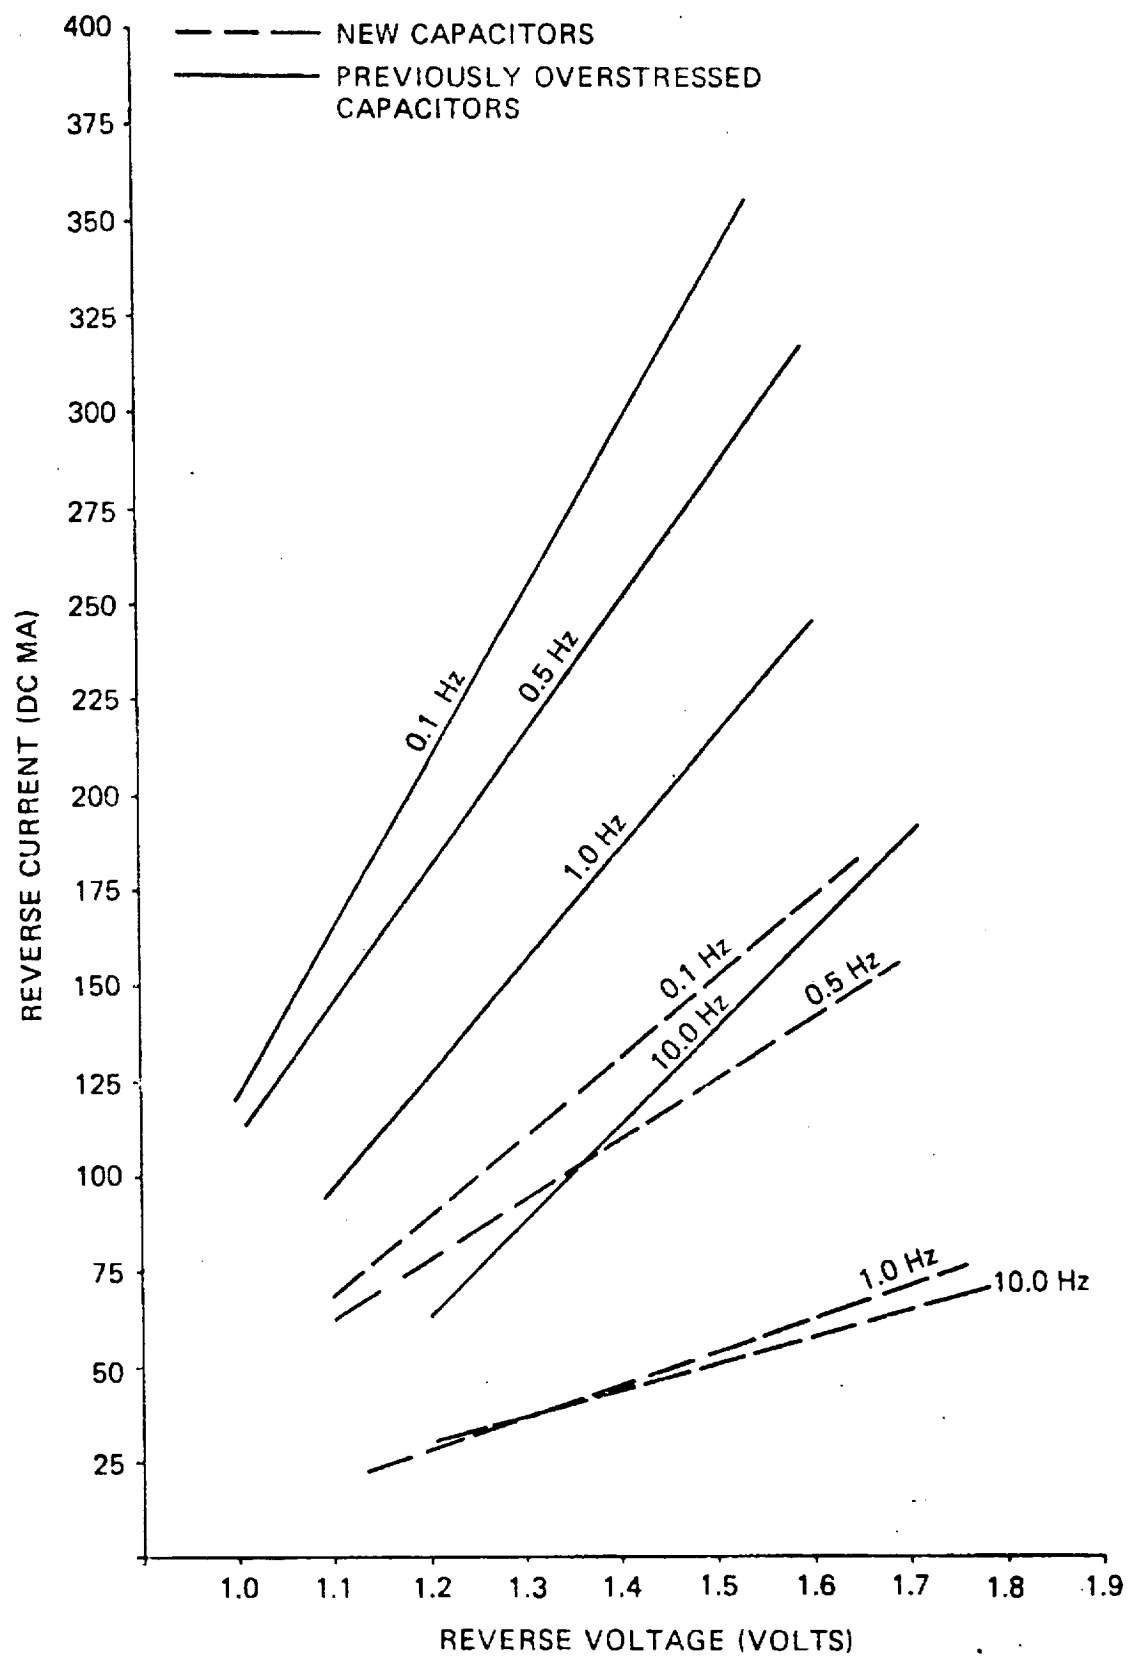
Figure 6.6.3.6-1. AC on DC Test Summary.

This test was an experiment to determine if the quantity of reverse bias leakage current is in any way related to the frequency of the applied voltage. The results of this test indicate that the leakage current is greater at lower frequencies. These results are summarized in Figure 6.6.3.6-1.

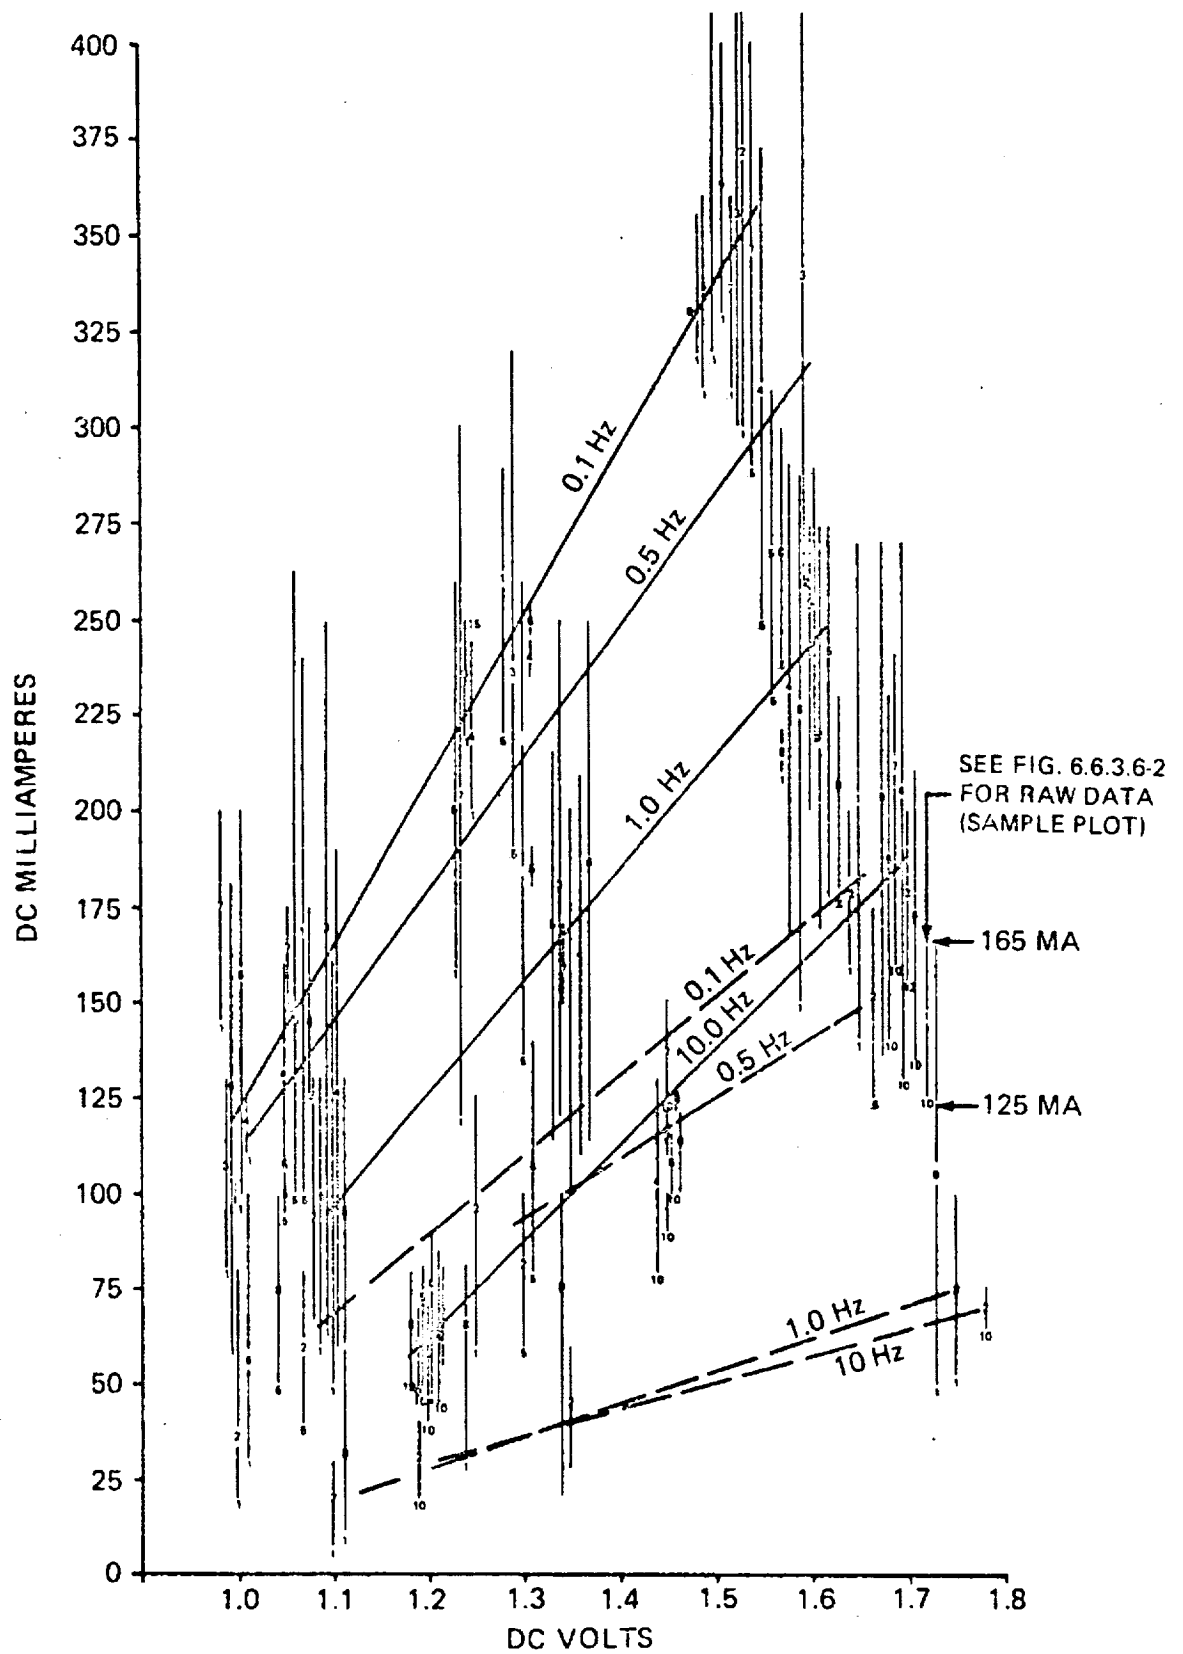
Figure 6.6.3.6-3. Detail Plots of AC on DC Test Data.

This test was performed on eight capacitors. Each capacitor was operated at four frequencies - 0.1 Hz, 0.5 Hz, 1.0 Hz, and 10.0 Hz. A sample run is shown in Figure 6.6.3.6-2. This sample shows test capacitor no. 1 being operated at 10.0 Hz. Data from these runs were used for plotting data points on Figure 6.6.3.6-3. After all points were plotted, diagonal lines connecting the average leakage currents at the given frequencies and voltages were drawn showing the overall leakage effect at a given frequency.
